Improper Aircraft Deicing in BNA Nashville

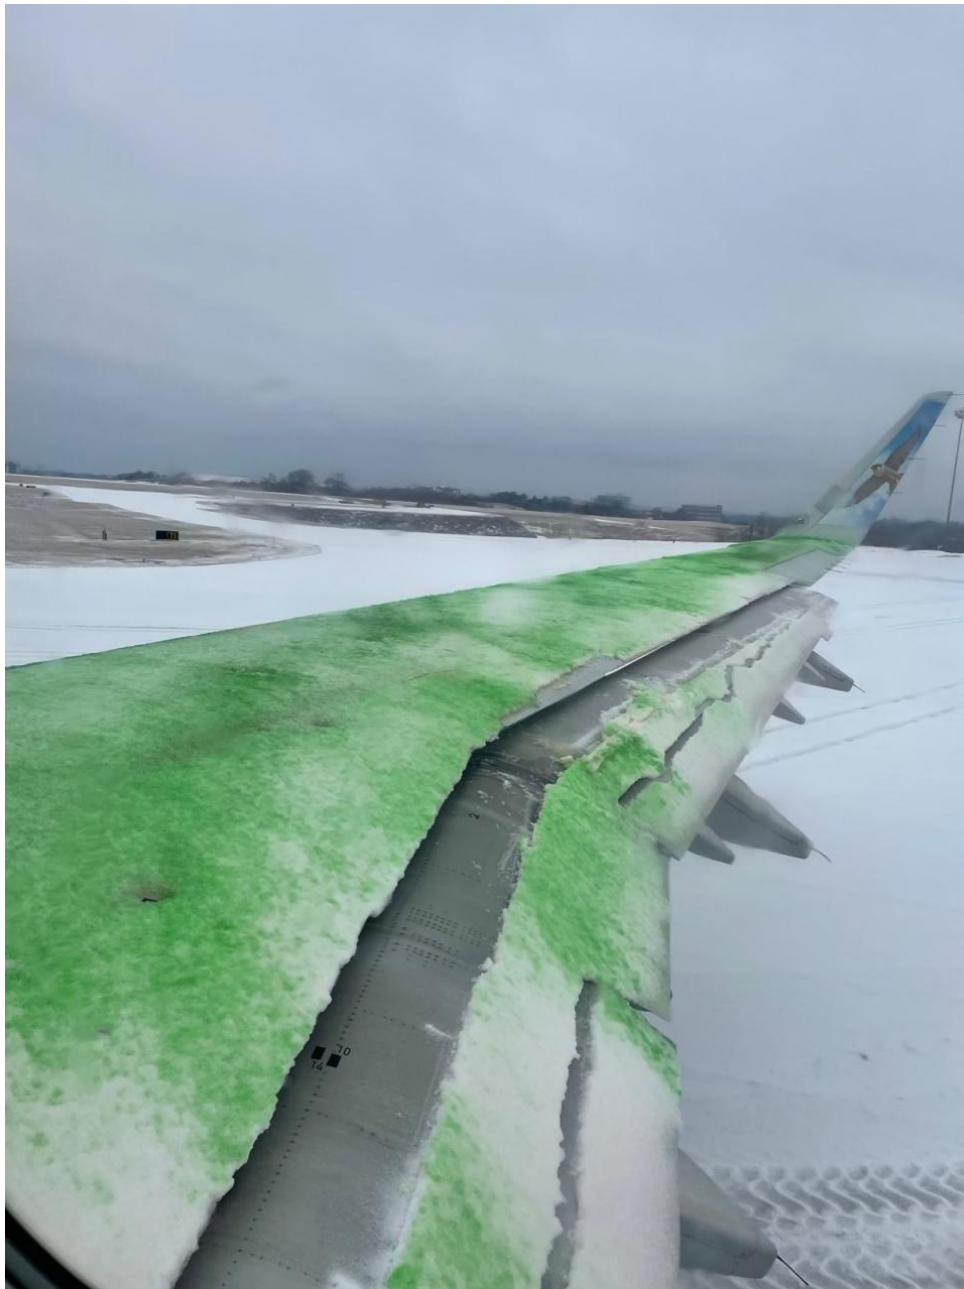
An aircraft requested a type 1 and 4 deicing from the deicing vendor. The vendor performed the deicing and reported to the flight deck crew that the aircraft was deiced and clear of contaminants. Upon reaching the runway and preparing for departure, an alarmed flight attendant called the flight deck stating that the wings were still covered with snow and ice. The flight crew visually inspected the wing and returned to the gate. Both wings did indeed still have snow and ice. It is clearly apparent the deicing crew did not remove the snow and ice with type 1 fluid before deicing with type 4. See photo below.
